Manhole Inspection Summary

Manhole # S17CC_012MH

Insp Date: **10/19/07 12:28 PM**

Location Address: **1116 TWINCHESTER ST**

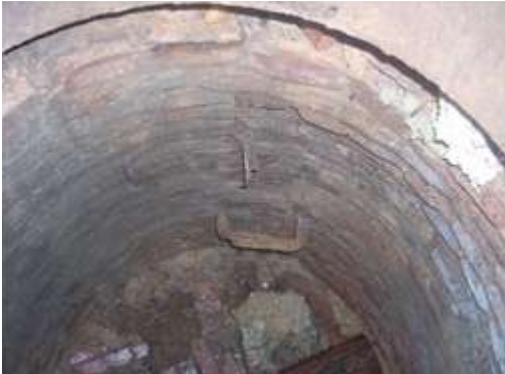
Defect 4

Count: **1** Missing: **1** ☒ Corroded

1 MISSING STEP 1 CORRODED STEP

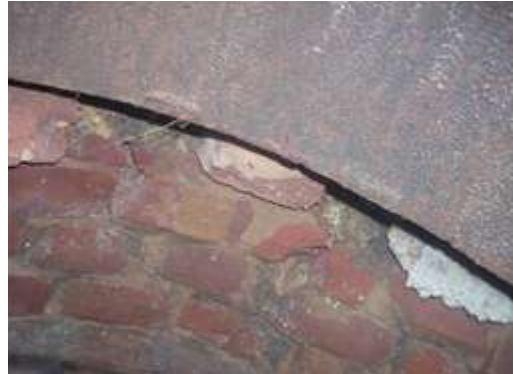
Defect 3

Condition: ☐ Sound ☒ Cracked ☐ Root Intrusion ☐ Loose Brick ☐ Deteriorated

CRACKED CORBEL

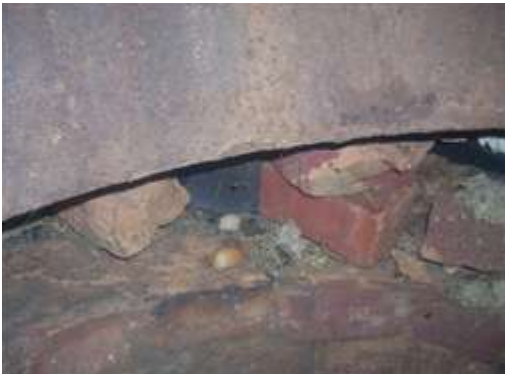
Defect 2

Condition: ☐ Sound ☐ Cracked ☐ Root Intrusion ☒ Loose Brick ☒ Deteriorated

DETERIORATED CHIMNEY AND
LOOSE CHIMNEY BRICKS

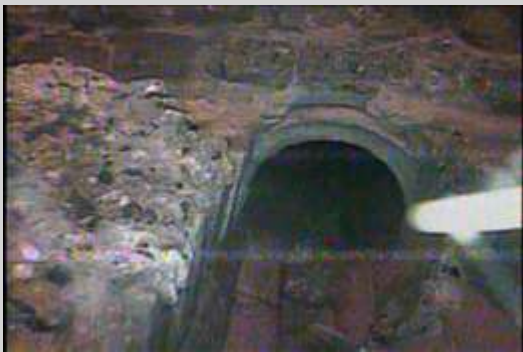
12 O'Clock Outflow

Pipe Height: **7.2** (in.) Rod and Bar (Angled)
Pipe Material: **Clay** ☐ Pipe Lined
Invert Depth: **7.34** (ft.) Flow Characteristics: **Slow**
Deposits: ☒ None ☐ Mud ☐ Sludge ☐ Debris ☐ Grease
Silt Depth: (in.) Deposits Extent:
Infiltration: **None** Pipe Seal Cond: **Sound**

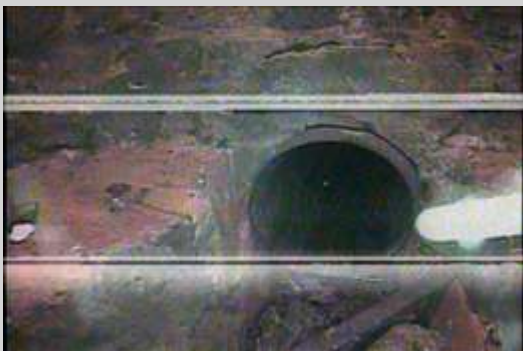
3 O'Clock Inflow

Pipe Height: **8.4** (in.) Rod and Bar (Angled)
Pipe Material: **Clay** ☐ Pipe Lined
Invert Depth: **6.94** (ft.) Flow Characteristics: **Slow**
Deposits: ☒ None ☐ Mud ☐ Sludge ☐ Debris ☐ Grease
Silt Depth: (in.) Deposits Extent:
Infiltration: **None** Pipe Seal Cond: **Sound**

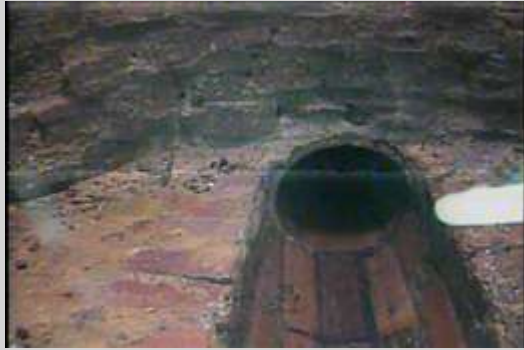
6 O'Clock Inflow

Pipe Height: **7.2** (in.) Rod and Bar (Angled)

Infiltration: **None** Pipe Seal Cond: **Sound**
